Plastic Sheeting IEC Material Overtime

Messaging on plastic sheeting is one of the most used in the shelter sector. The illustrations are recurrently being used to create different material and can be traced back to "Plastic sheeting: A guide to the use of plastic sheeting in humanitarian relief: Oxfam, IFRC 2007". This inter-agency booklet itself was an update and drew heavily on the content and illustrations of Jim Howard and Ron Spice's original book on plastic sheeting in 1973.

Section B

REVIEWS

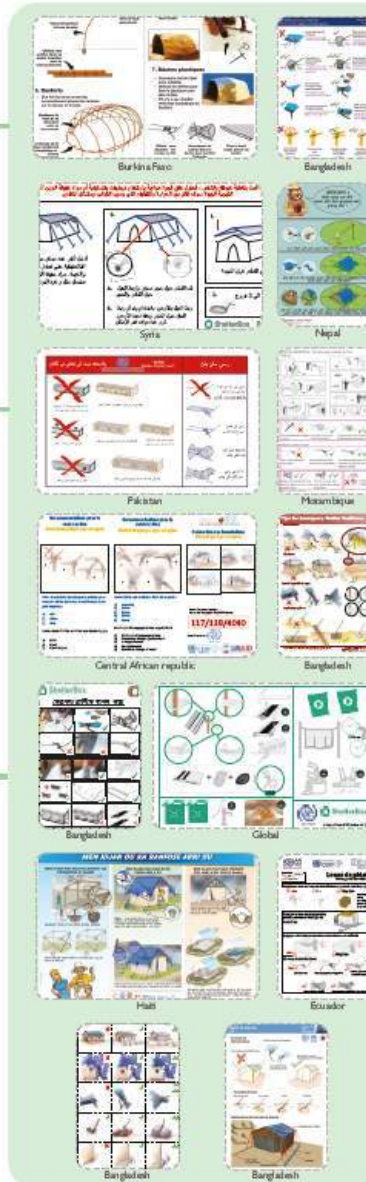
Different iterations

This tree chart demonstrates the development and use of one of the illustrations depicted in the booklet, and its uses over time for different shelter and settlements responses. The timeline shows how various guidance material adapted this illustration in different ways, which allowed it to be adapted in other contexts as well as in other IEC material. The graphic also captures the various contexts, illustration styles and IEC materials that include this message.

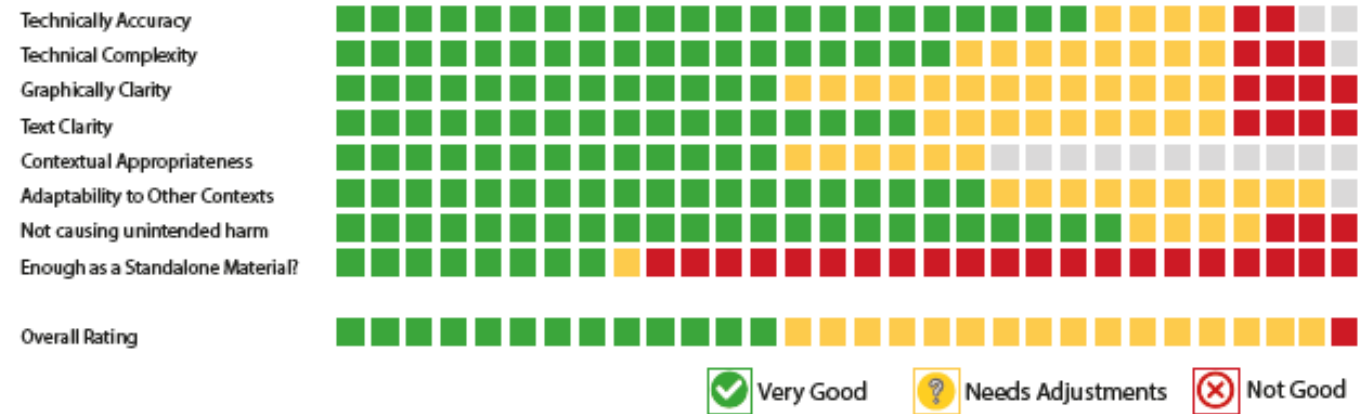
Feedback against the reviewing criteria

This graph shows the feedback received from *thirty experts* reviewing the IFRC Shelter Kit IEC material on different criteria.
